# **Mobile Pentium® II Processor Specification Update**

Release Date: May 1999

Order Number: 243887-010

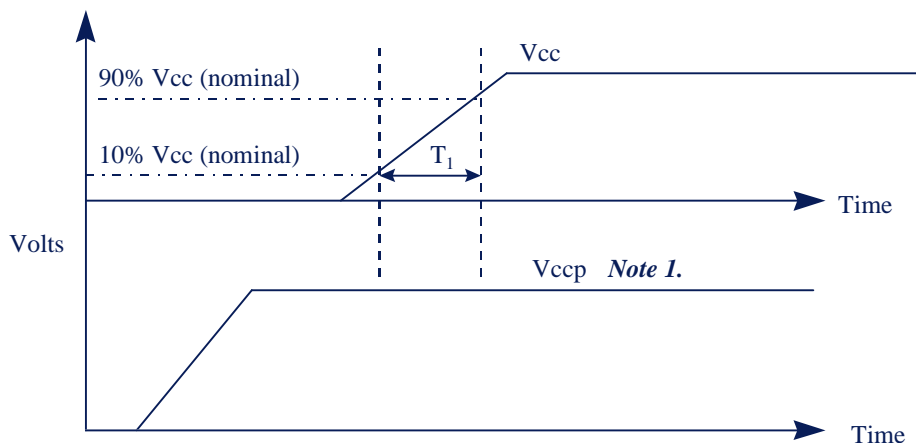
**Figure 1. V<sub>CC</sub>/V<sub>CCP</sub> Timing Requirements (Mobile)**

**PROBLEM:** The processor uses the PWRGOOD signal to ensure that no voltage sequencing issues arise; no pin assertions should cause the processor to change its behavior until this signal is asserted, when all power supplies and clocks to the processor are valid and stable. However, if  $V_{CC}$  ramps up before  $V_{CCP}$ , it will cause the processor to enter an invalid state.

**IMPLICATION:** If this erratum occurs, the system may boot normally however, the L2 cache may not be initialized.

**WORKAROUND:** For Mobile Pentium II processors, ensure that  $V_{CC}$  ramps after or with the L2 cache IO voltage ( $V_{CCP}$ ). If  $V_{CCP}$  ramps after the  $V_{CC}$ , a delay circuit can be placed on the core  $V_{CC}$  to ensure that  $V_{CC}$  ramps at the same time or after  $V_{CCP}$  as shown below in Figure 1.

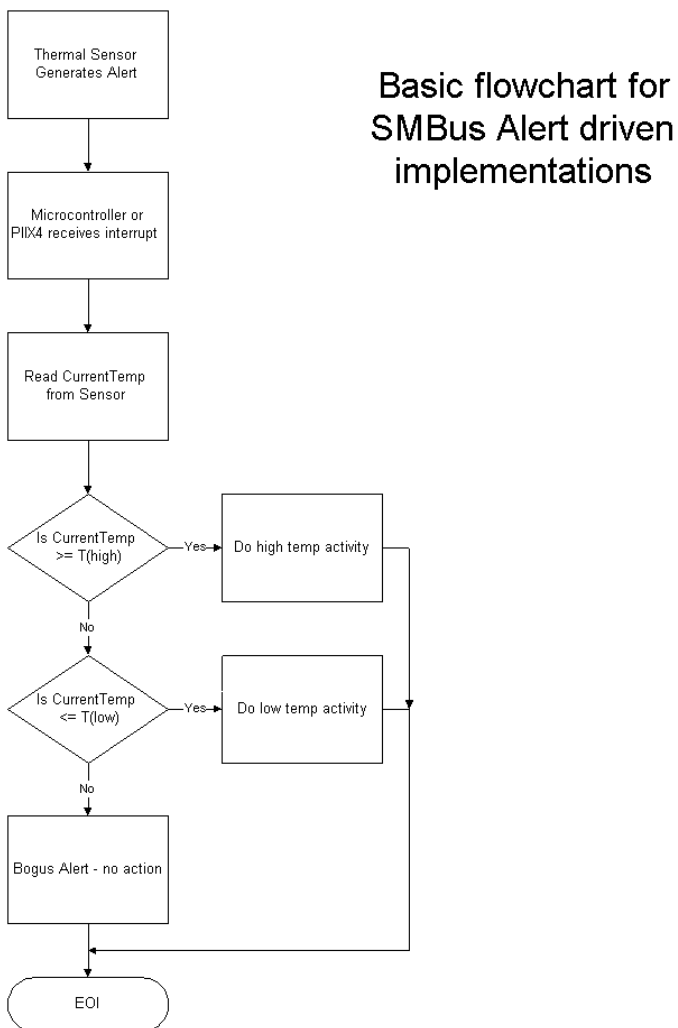
**Figure 2. Workaround Flowchart: SMBALERT#-Driven System**

Under the conditions described below, the thermal sensor incorrectly generates the SMBALERT# interrupt. *All* of the following conditions must be met to trigger a false interrupt:

1. Before servicing an interrupt from the thermal sensor, read and compare the processor thermal reading with the threshold limits ( $T_{HIGH}$  or  $T_{LOW}$ ). Figures 2 and 3 provide basic flowcharts for the implementation of this workaround in an interrupt driven system.
2. If the firmware implemented polls the Status Register only, then before taking any action, re-read the temperature register and do a comparison with the alarm threshold limits ( $T_{HIGH}$  or  $T_{LOW}$ ) to determine if the value is actually still within the temperature window.
3. Use a temperature polling scheme to monitor the processor temperature.

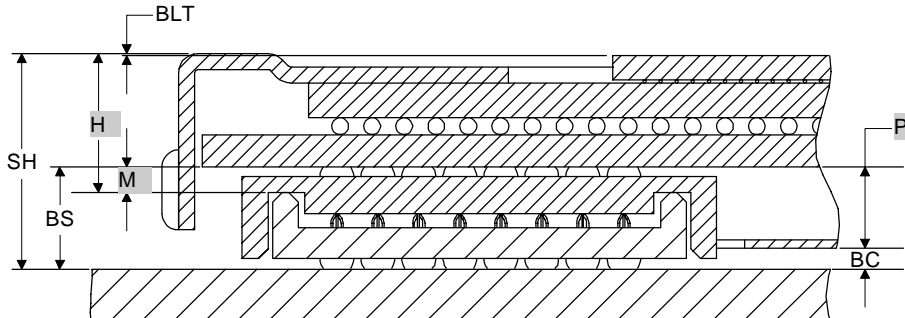
Figure 5.6. Cross Sectional View with Vertical Dimensions

### B1. Misabeled Vertical Dimension Parameters

Figure 5.6 in the *Mobile Pentium® II Processor at 233 MHz, 266 MHz, and 300 MHz* datasheet should be replaced by the following figure:

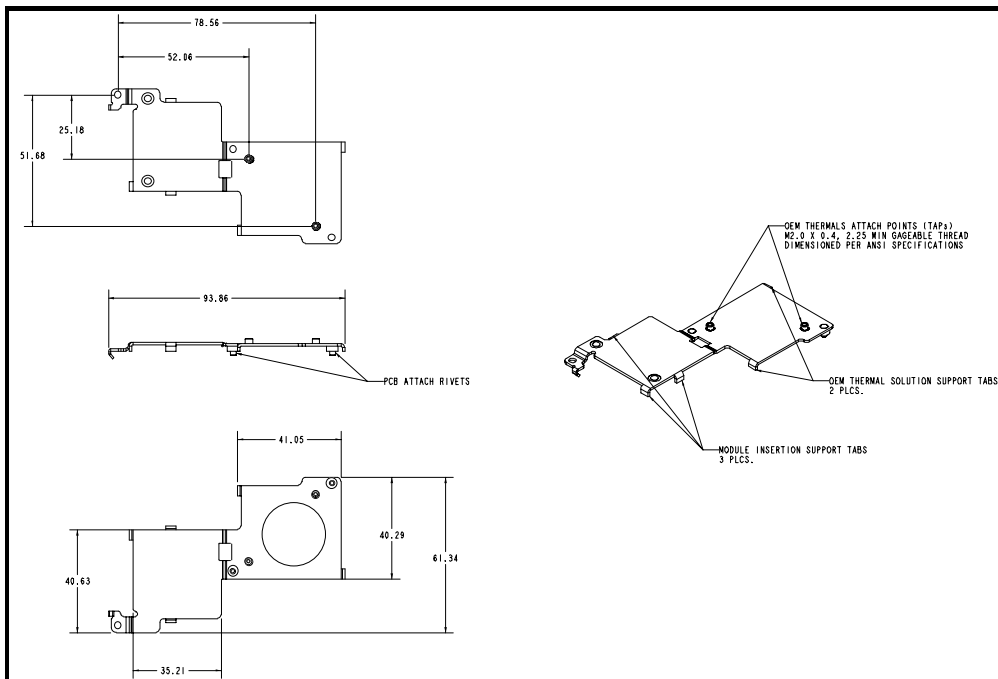
Figure 1. TAP Gageable Thread Clarification

OEM Thermal Attach Points (TAPs) M2.0 x 0.4, 2.25 min gageable thread dimensioned per ANSI specification.
